DEPARTMENT OF TRANSPORTATION

Quality Assurance and Source Inspection

Contract #: 04-0120F4Cty: SF/ALA Rte: 80 PM: 13.2/13.9File #: 69.28**WELDING INSPECTION REPORT****Resident Engineer:** Pursell, Gary**Address:** 333 Burma Road**City:** Oakland, CA 94607**Report No:** WIR-013292**Date Inspected:** 15-Mar-2010**Project Name:** SAS Superstructure**OSM Arrival Time:** 700**Prime Contractor:** American Bridge/Fluor Enterprises, a JV**OSM Departure Time:** 1900**Contractor:** Zhenhua Port Machinery Company, Ltd (ZPMC), Changxing Island **Location:** Shanghai, China**CWI Name:** Yu Dong Ping, Tu Jun**CWI Present:** Yes No**Inspected CWI report:** Yes No N/A**Rod Oven in Use:** Yes No N/A**Electrode to specification:** Yes No N/A**Weld Procedures Followed:** Yes No N/A**Qualified Welders:** Yes No N/A**Verified Joint Fit-up:** Yes No N/A**Approved Drawings:** Yes No N/A**Approved WPS:** Yes No N/A**Delayed / Cancelled:** Yes No N/A**Bridge No:** 34-0006**Component:** Tower**Summary of Items Observed:**

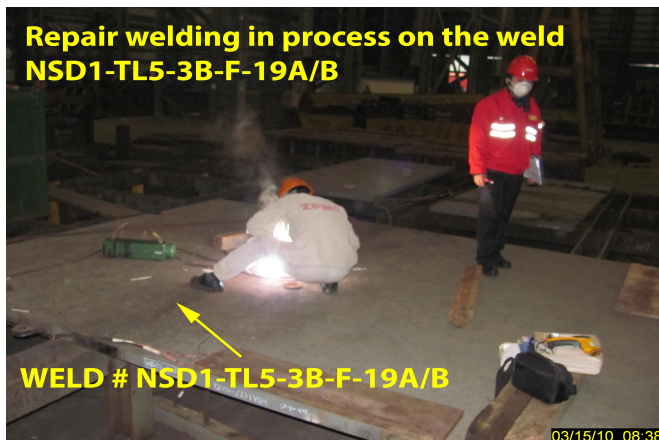
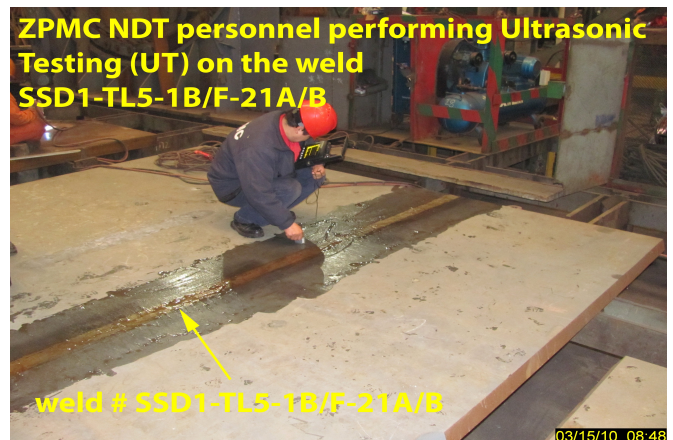
This QA inspector observed that ZPMC NDT personnel were performing Ultrasonic Testing (UT) on the weld joints SSD1-TL5-1B/F-13A/B & SSD1-TL5-1B/F-21A/B. Non confirming indications were found on both the joints. Attached photographs provide additional details.
